FABRIC INSPECTION REPORT N010

Barrel USA

A. GENERAL INFORMATION			
Factory Name:	Shaoxing Yangshi Textile Co.,Ltd		
Color Name:	Black, Orange, Neon Yellow		
Product PO:	N/A		
Product Item/Style:	N/A		
Inspection Date:	Jan 08,2017	Inspection Location:	Shaoxing, Zhejiang, China

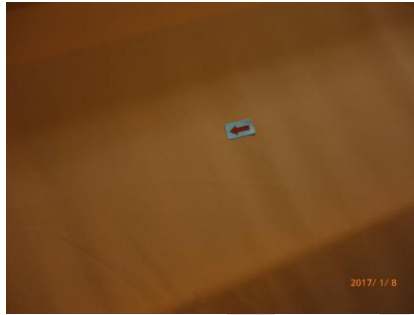
2.	For color Orange, there were total 77 meters length "Crease Mark" in the Roll (4) in wrap yarn direction and total 51 meters length "Crease Mark" in the Roll (3) in wrap yarn direction, besides, the crease mark appeared in different position in the same roll, for details please refer to photo.It was very hard to avoid these defect fabrics during cutting fabric.

3.	For color Neon Yellow, "Crease Mark" was found in the whole Roll (1) (total 139meters) in wrap yarn direction besides, the crease mark appeared in different position in the same roll.It was very hard to avoid these defect fabrics during cutting fabric.

Photo 5) Crease Mark

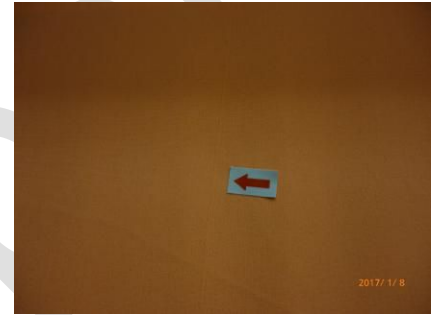
Photo 6) Crease Mark

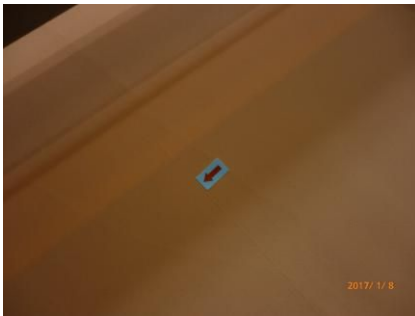
Photo 7) Crease Mark

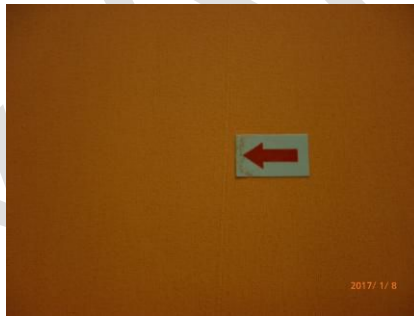
Photo 8) Crease Mark

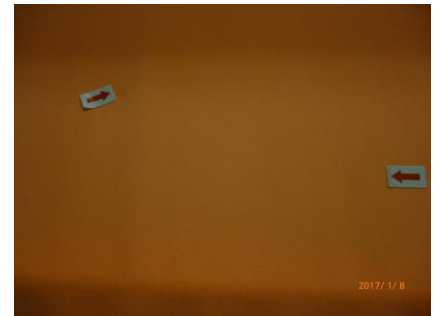
Photo 9) Crease Mark

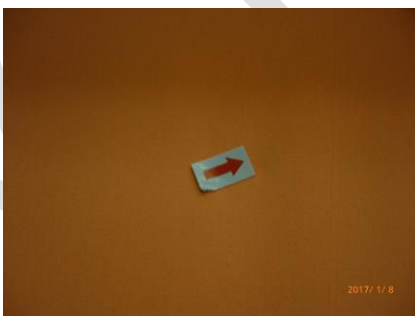
Photo 10) Crease Mark

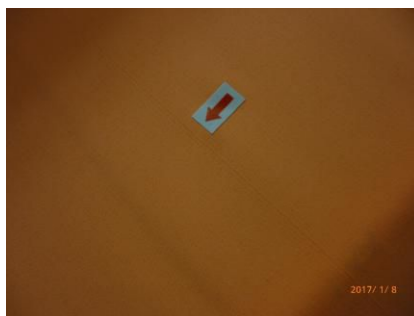
Photo 11) Crease Mark

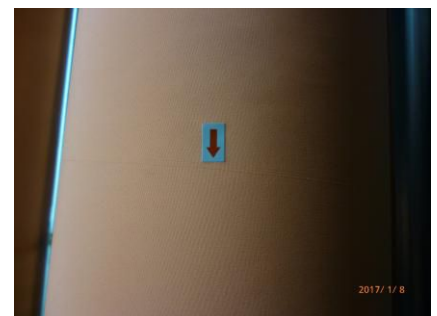
Photo 12) Crease Mark

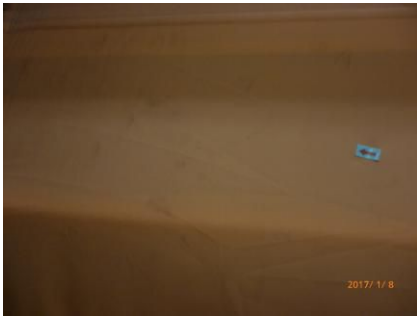
Photo 13) Dirty mark

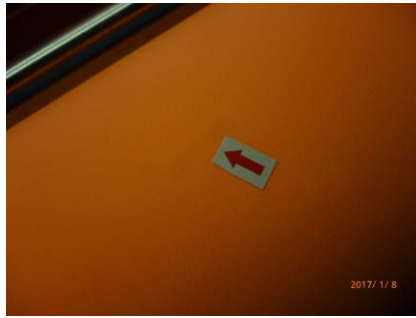
Photo 14) Dirty mark

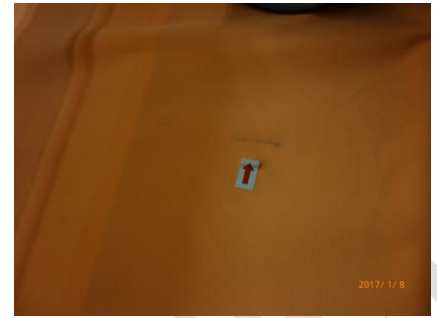
Photo 15) Dirty mark

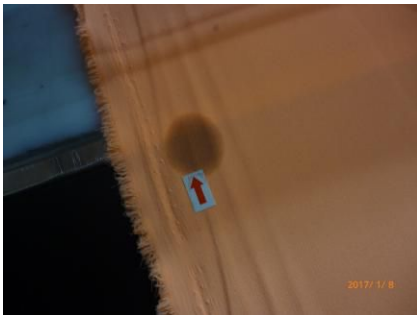
Photo 16) Oil mark

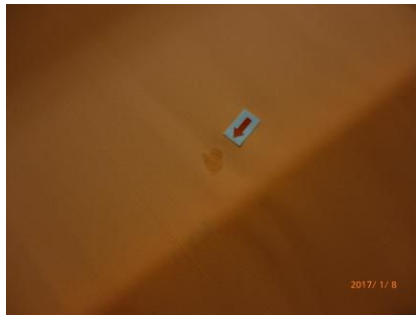
Photo 17) Oil mark

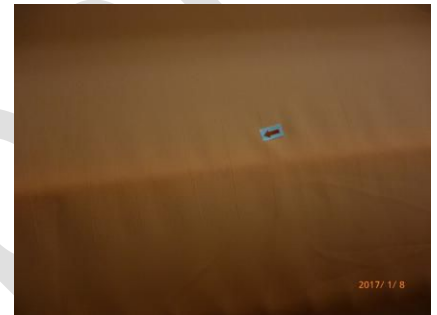
Photo 18) Filling Bar

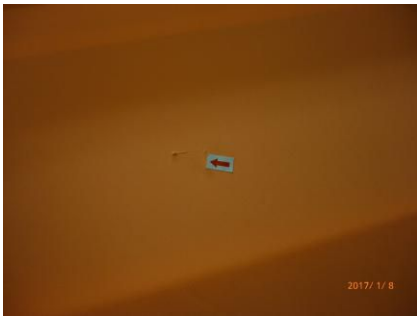
Photo 19) Snag yarn

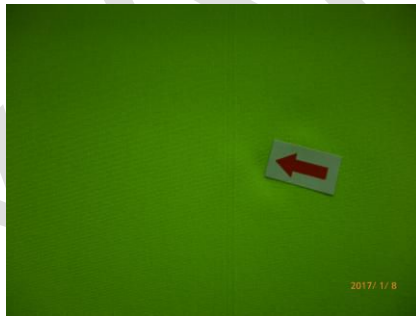
Photo 20) Crease Mark

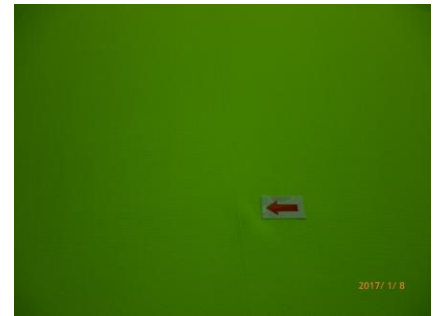
Photo 21) Crease Mark

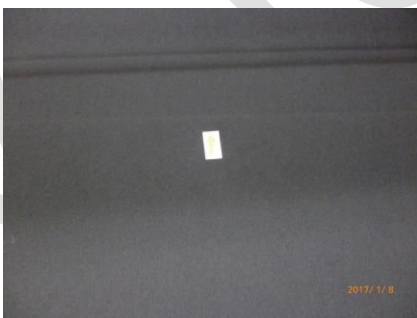
Photo 22) Stop mark

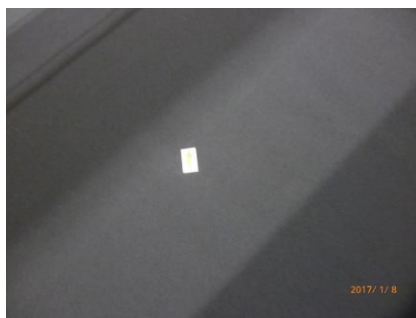
Photo 23) Stop mark

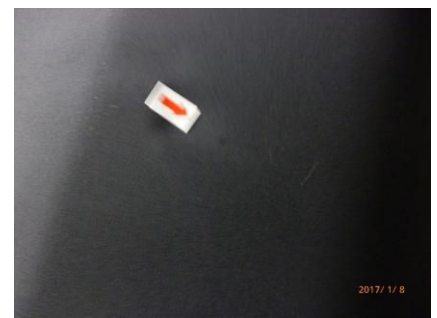
Photo 24) Oil mark

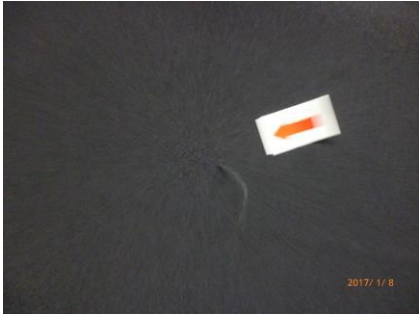
Photo 25) Snag yarn
